Heritage @ Risk

Canterbury Provincial Council Buildings Christchurch

Jenny May

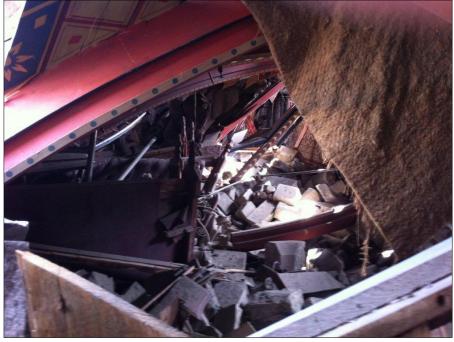
Large sections of the ridge and furrow ceiling have been retrieved. Stone corbels in part and some almost complete have been found within the rubble and where possible identified through existing photographic records as to their exact position.

Little has remained intact of the chamber's stained glass windows however every found fragment is carefully collected, recorded and stored for examination by a stained glass conservator.

The encaustic tiles on the east wall have remained largely intact in situ;

large areas of the tiling on the west wall also remain.

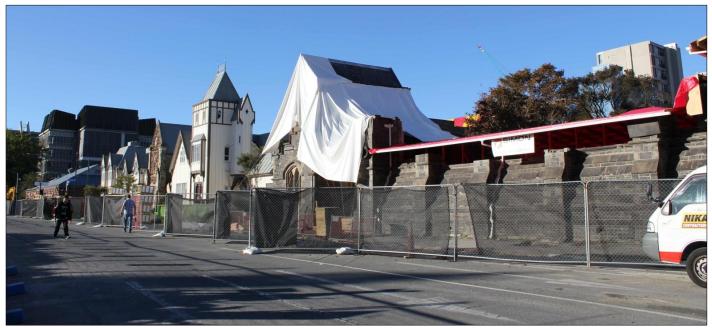
n 22 February 2011 the 1865 Stone Chamber of the Canterbury Provincial Council Buildings collapsed. This earthquake and the subsequent year of seismic activity have severely damaged other parts of the complex. The Armagh Street stone tower collapsed; the Bellamy's wing and the Durham street stone tower have been considerably damaged; chimneys have fallen or had to be removed.

The former provincial councillors' refreshments rooms of 1865, *Bellamys*, though strengthened, has suffered considerable damage due to both shaking and lateral ground spread toward the river. The timber sections of the complex have also suffered some damage from falling masonry and ground spread but, in general, remain intact.
