Heritage @ Risk

Canterbury Provincial Council Buildings Christchurch

Jenny May

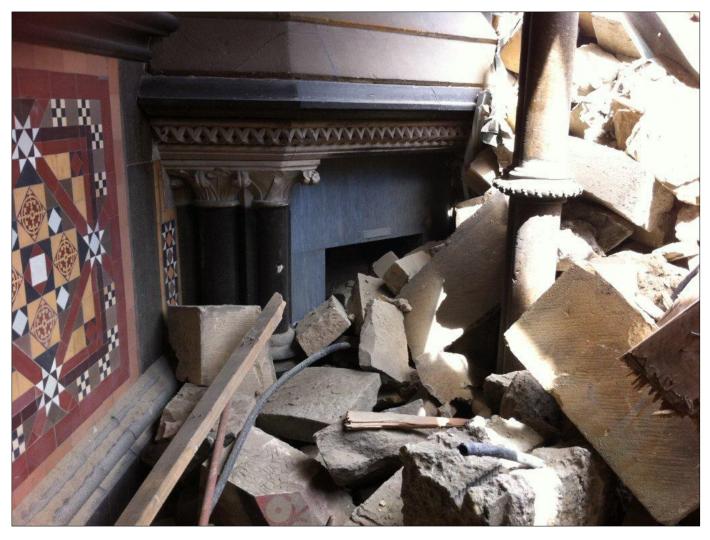
n 22 February 2011 the 1865 Stone Chamber of the Canterbury Provincial Council Buildings collapsed. This earthquake and the subsequent year of seismic activity have severely damaged other parts of the complex. The Armagh Street stone tower collapsed; the Bellamy's wing and the Durham street stone tower have been considerably damaged; chimneys have fallen or had to be removed.
